WHOI-90-46

**Arctic Remote Autonomous Measurement Platform
Post CEAREX Engineering Report**

November, 1990

Technical Report

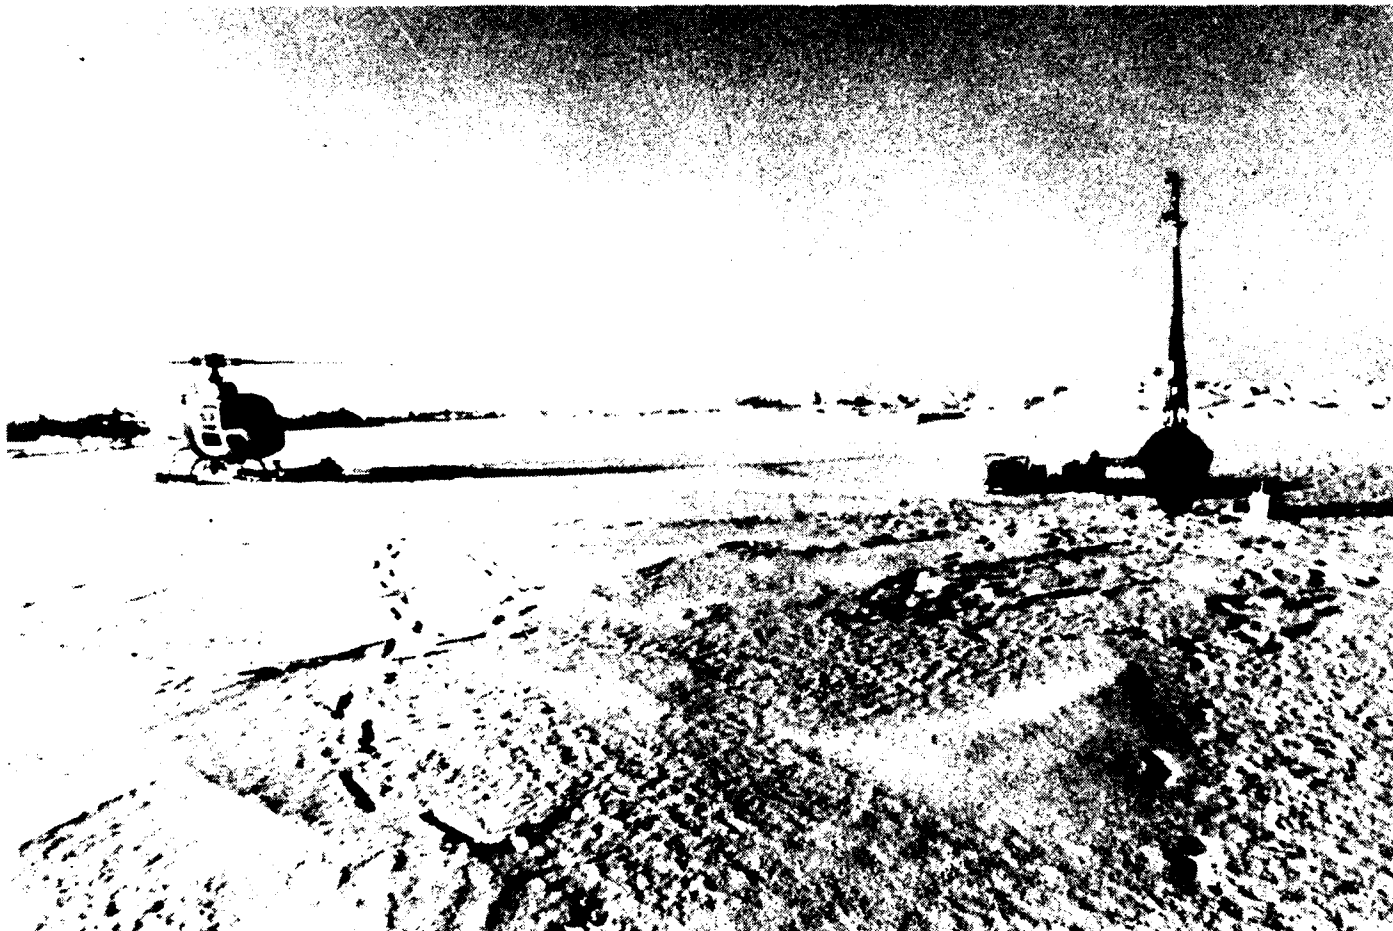
Figure 1. The ARAMP buoy with meteorological tower deployed in pack ice during CEAREX. Helicopter used to transport equipment to remote site.
